**Request for Proposal
For
Demolition of building at 100 Livingston Boulevard and
200 E. Seventh Street, Gaylord, Michigan
Otsego County, Michigan**

BID 2012-03

March 30, 2012

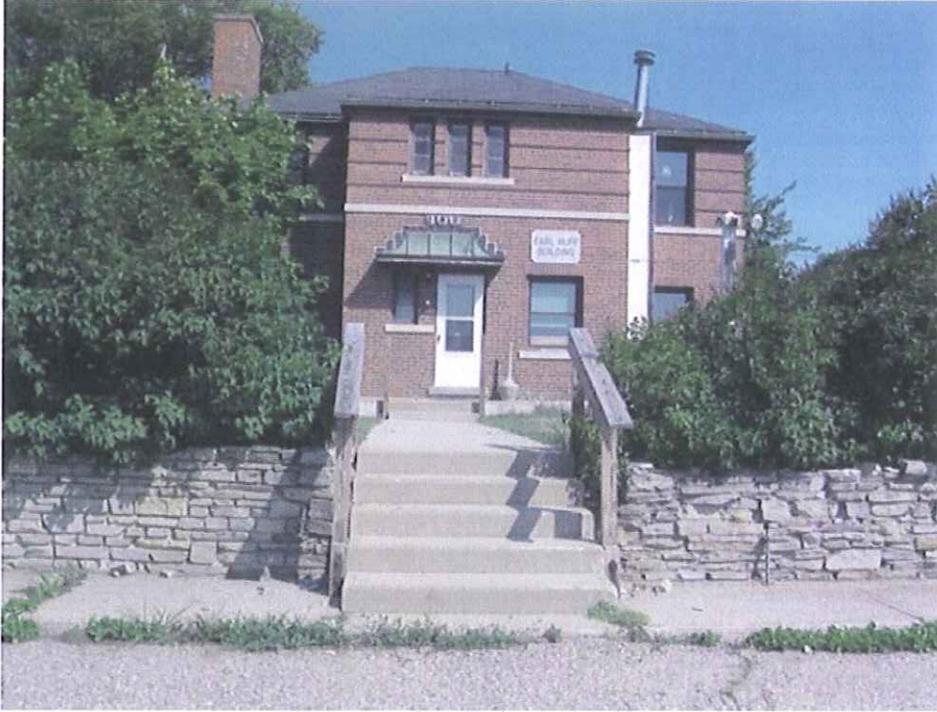
100 Livingston Blvd.-Old Prosecutor's Office

- 1) Demolition of the approximately 30' x 40' 2-story brick building at 100 Livingston Boulevard (see Attachment B). The structure does have a basement.

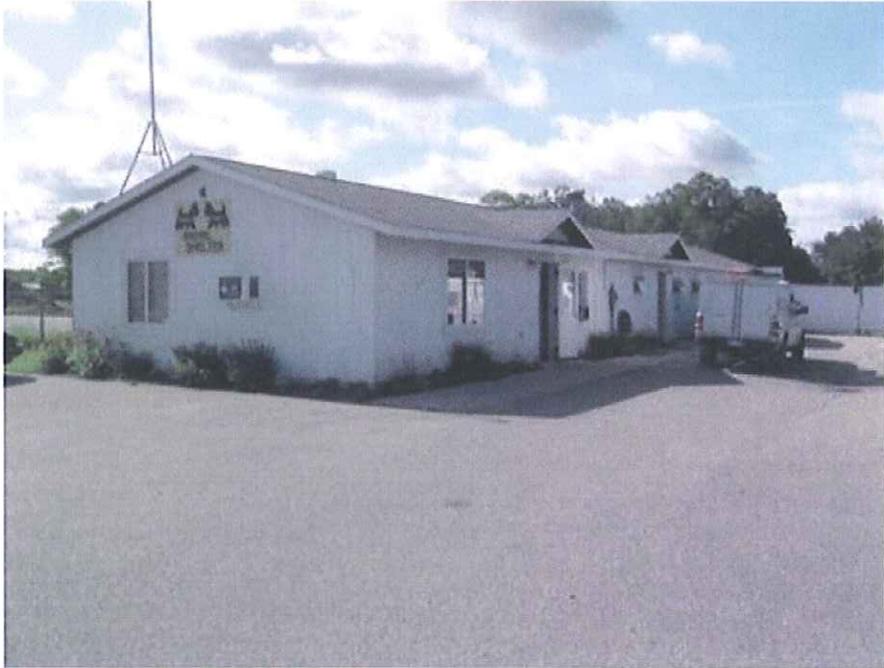
Animal Shelter-200 E. 7th St.

- 2) Demolition of the approximately 26' x 106' 1-story building at 200 E. Seventh Street (see Attachment C). Approximately 2/3 of the outer-walls of the building is block, while the remaining is a typical wood-frame building.

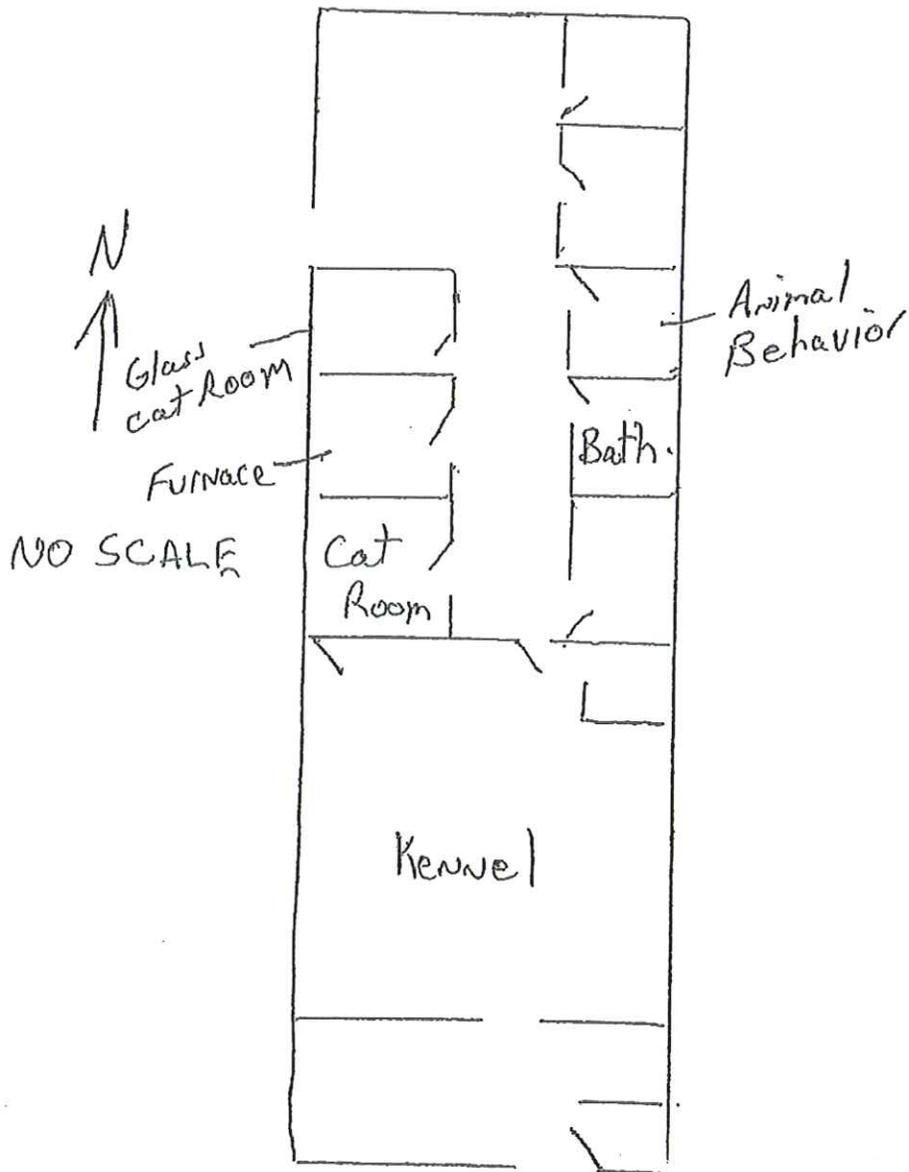
APPENDIX C

Client:

Otsego County

Site:

Animal Control

Of the 8 materials sampled, 2 tested positive for asbestos content and thus are defined as ACBM. A description of the ACBM, locations, and approximate quantities is provided on the table located in Appendix B. The location of the ACBM can be compared to the site plan located in Appendix C.
