**Request for Proposal for
Demolition and Disposal of
Buildings and Debris on
Various Foreclosed Properties
Otsego County, Michigan**

BID 2020-08

**RE: Asbestos, Lead-Based Paint & Mold Survey & Sampling
Residential Home – 1908 John Street – Bagley Twp.
Residential Home – 2887 Pine Grove Street – Hayes Twp.
Residential Home & Outbuildings – 1531 North Townline Road – Livingston Twp.
Gaylord, Otsego County, Michigan
Sagasser & Associates, Inc. Project #82003**

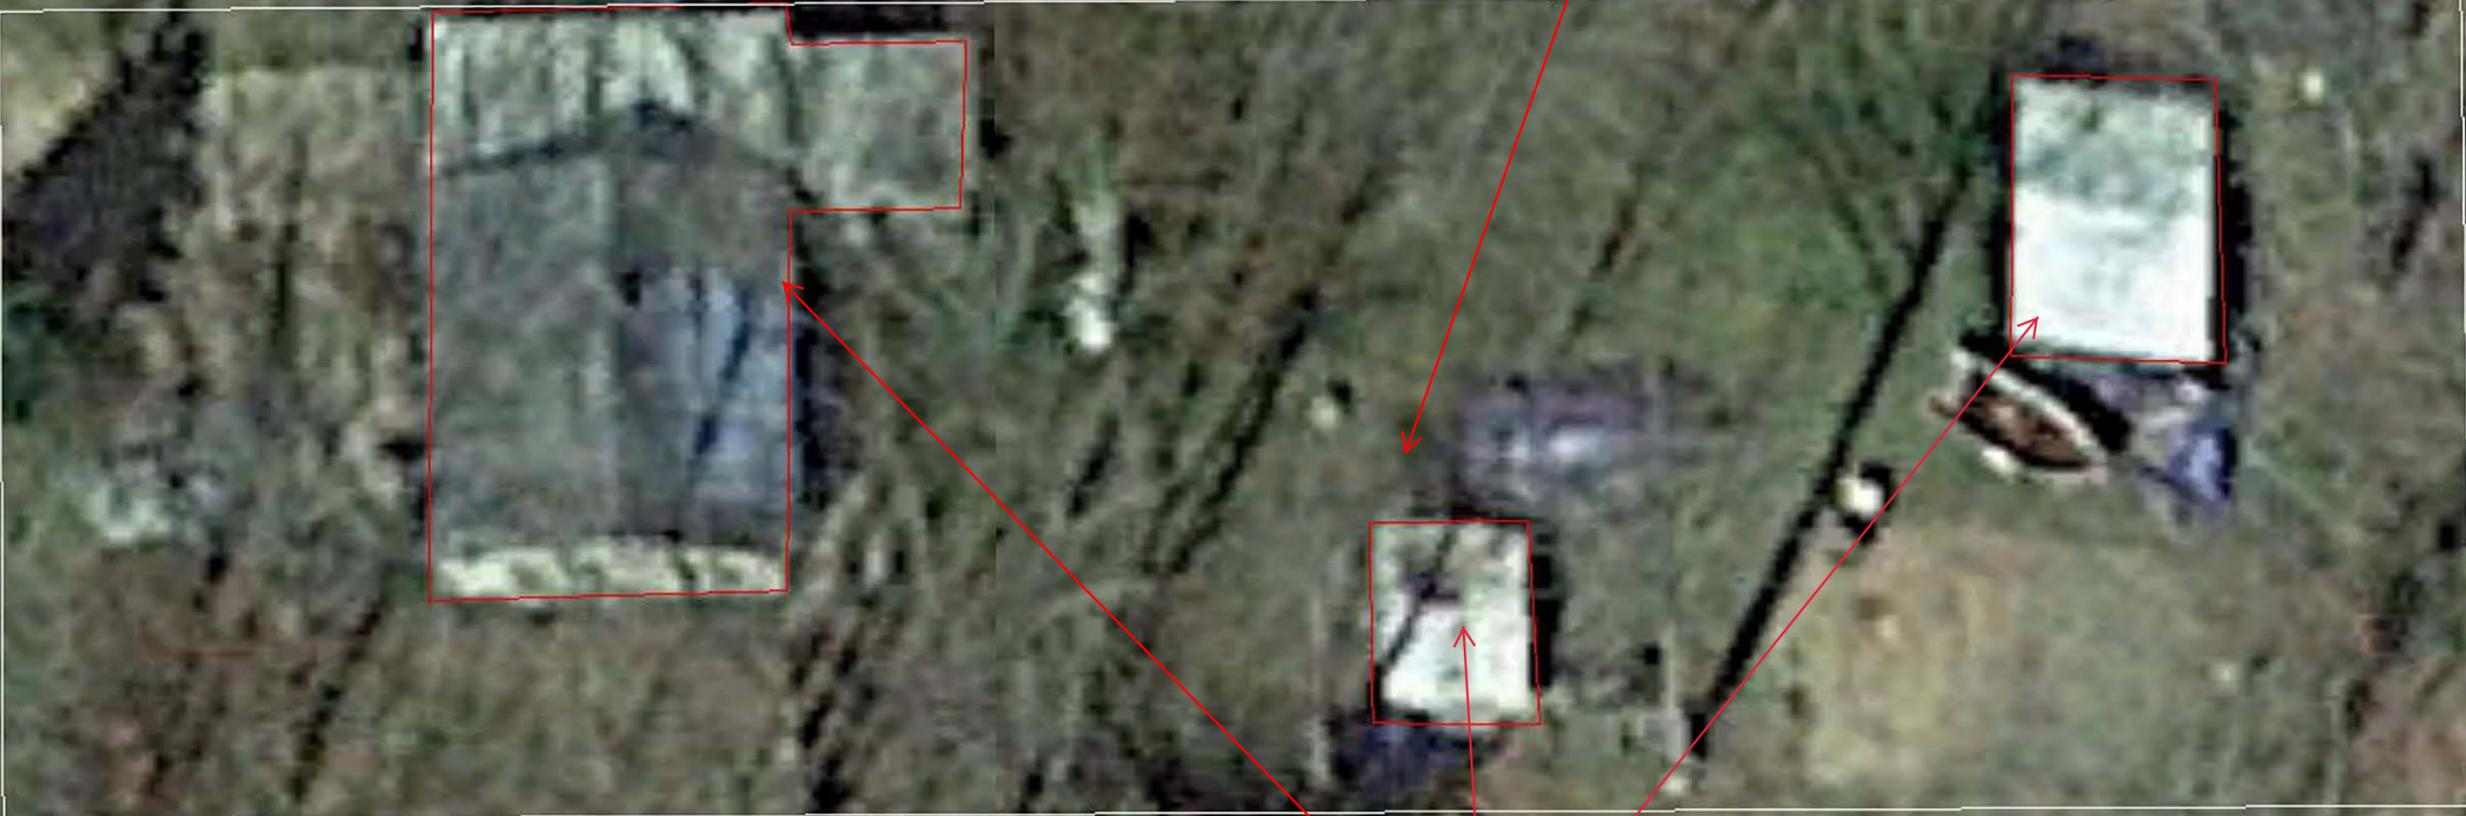
Neighboring structures to be protected.

Miscellaneous junk and debris to be disposed of and/or removed from property. Lot should be vacant once complete.

House and outbuildings (including all contents) to be demolished and disposed of.

***NOTE: Overview map is for information only. Total extent of work is as described in the RFP.**

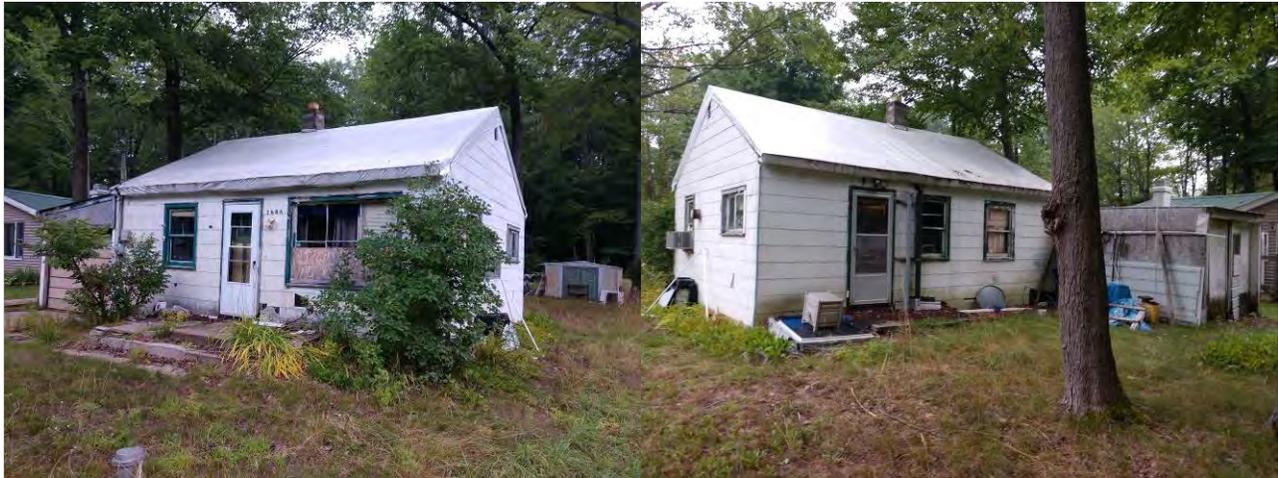
General views of residential home located at 1908 John Street.

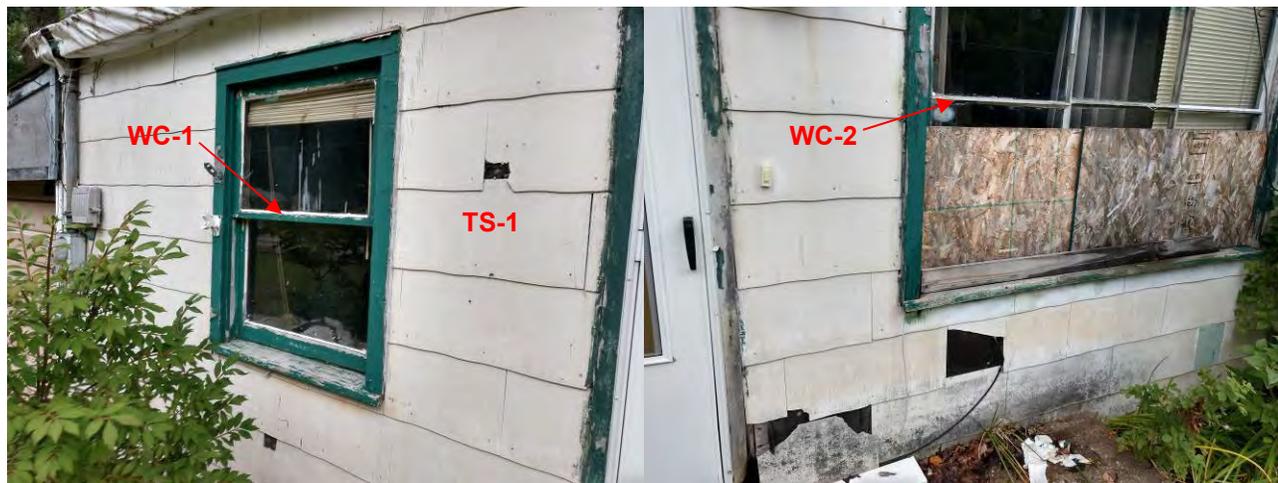
View of asbestos-containing window glazing sample locations and asbestos-containing transite siding.

The transite siding and the two types of window glazing were determined to contain asbestos. The kitchen sink undercoating is presumed to contain asbestos.

Transite Siding ~ 950 ft²

Window Glazing ~ 2 ft²

- Approximately 950 ft² of asbestos containing transite siding and approximately 2 ft² of window glazing was identified in the residential home located at 1908 John Street. The limited areas of painted building components were identified and no paint sampling was conducted. Additionally, no areas of mold were observed in the building. In a demolition, cementitious ACM (a.k.a. transite siding) cannot remain in a structure, as it is likely to become regulated in the demolition/handling process and must be removed prior to demolition. The window glazing is classified as a Category II non-friable ACM.

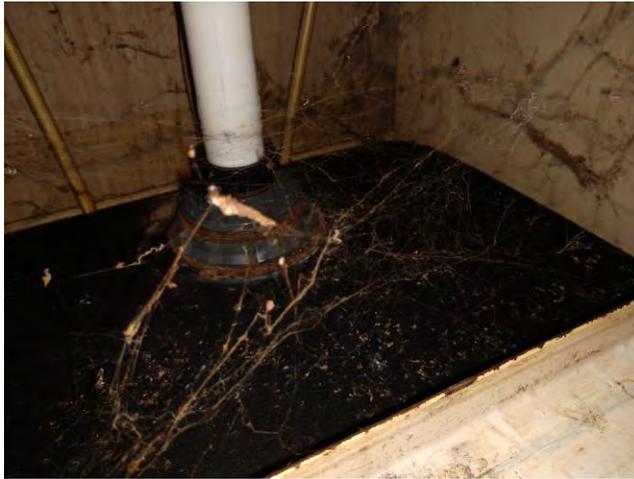
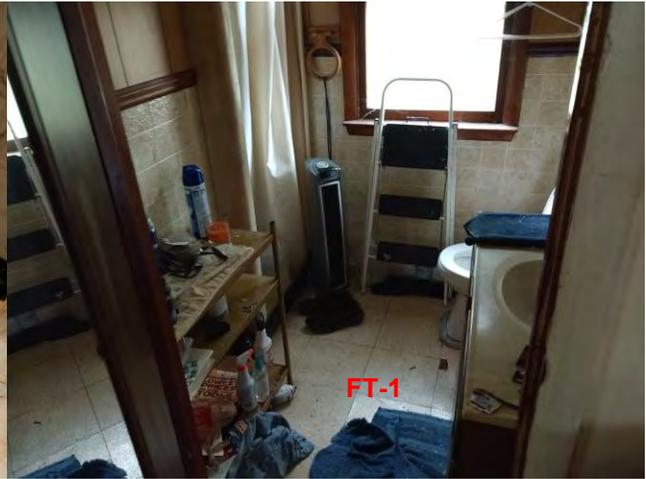
View of presumed asbestos-containing kitchen sink undercoating and 12"x12" floor tiles in bathroom.

Kitchen Sink ~4 ft²

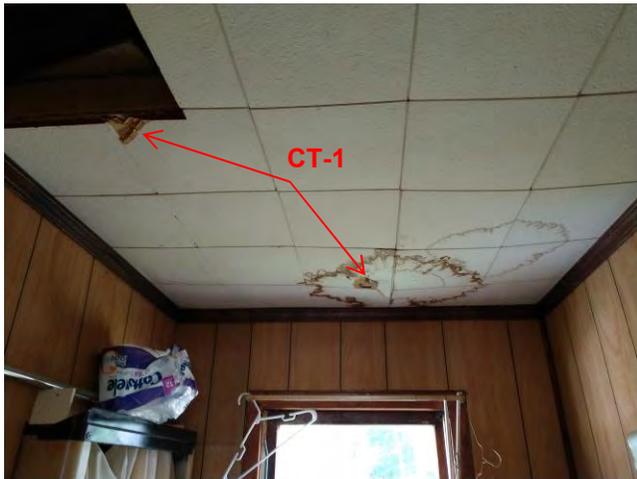
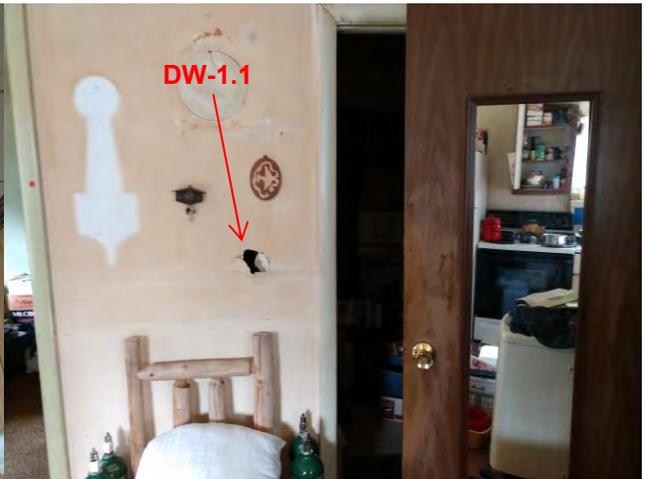
View of 12"x12" ceiling tiles in bathroom and drywall sample location.

The samples of all of the 12"x12" floor tiles, 12"x12" ceiling tiles, drywall, two types of tar paper and roof shingles were determined not to contain asbestos.

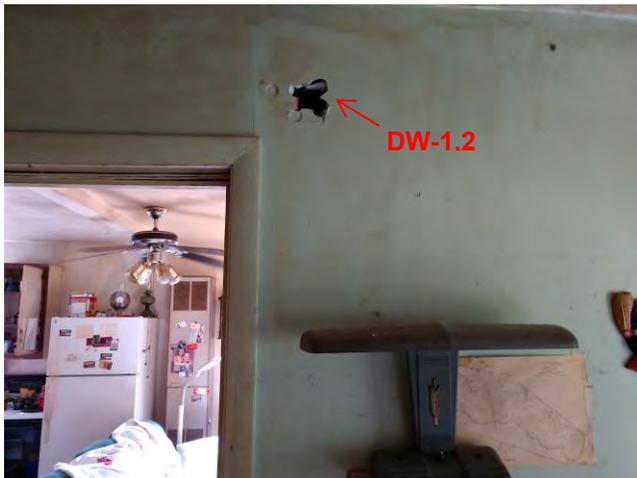
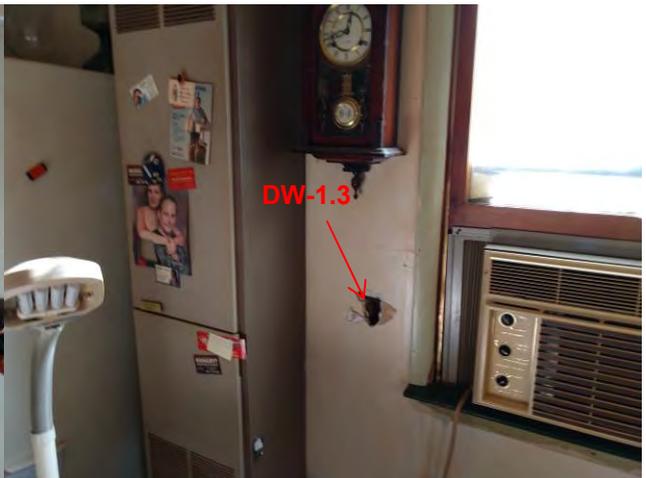
View of drywall sample locations.

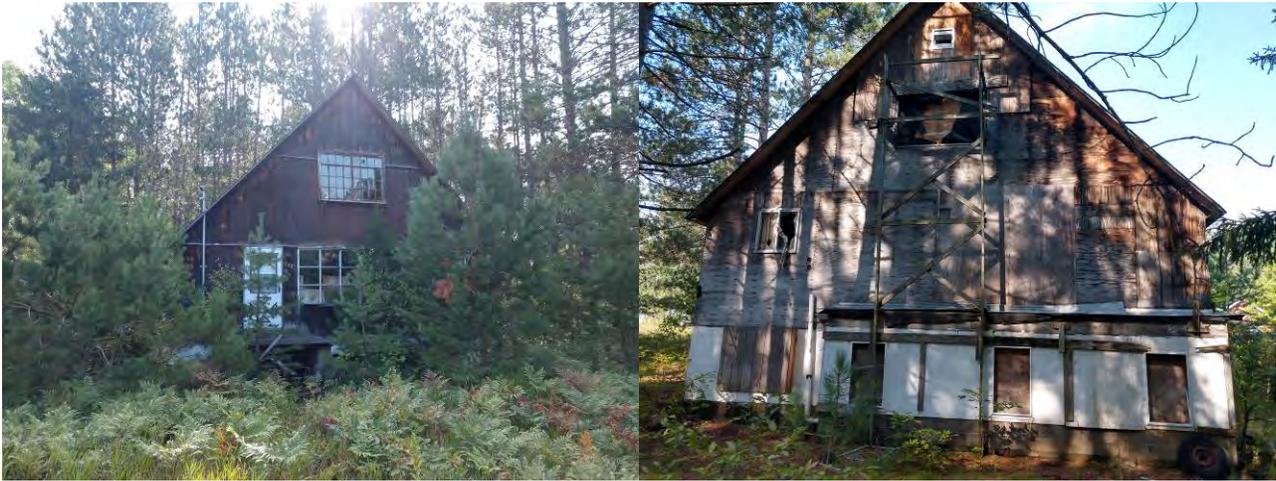
General view of residential home located at 2887 Pine Grove Street.

- No asbestos containing materials were identified in the residential home located at 2887 Pine Grove Street. No painted surfaces were identified. Only a small area of mold on drywall in the basement was observed.

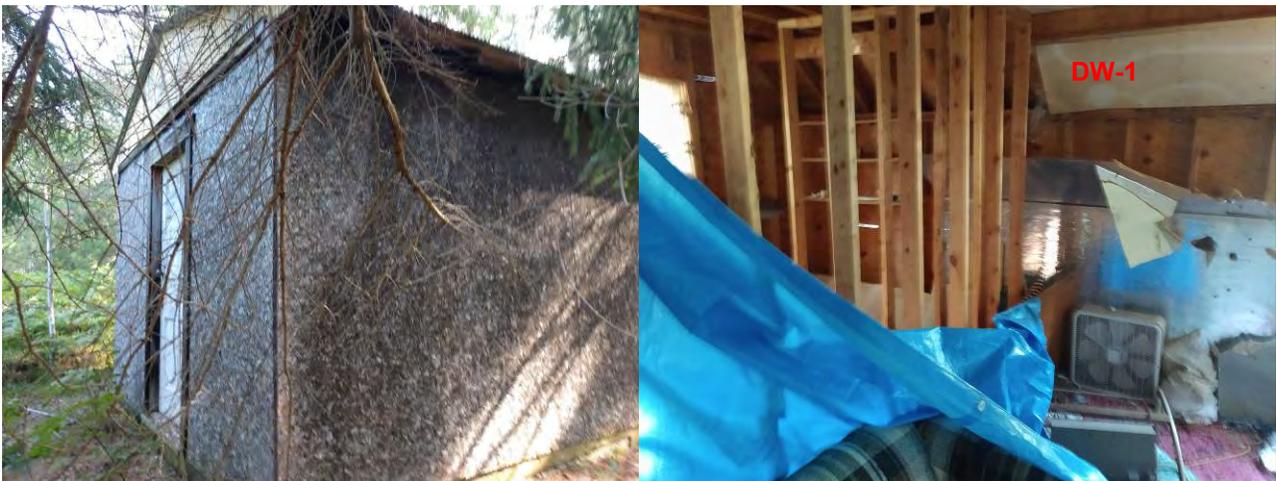
View of shed and interior view of drywall.

The samples of the drywall and roof shingles were determined not to contain asbestos.

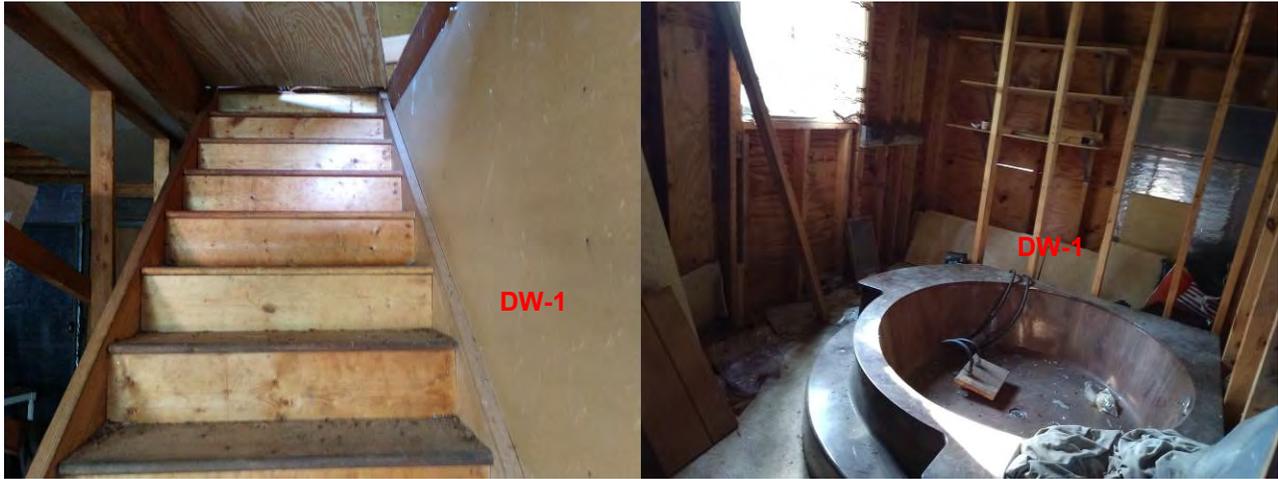
View of non-ACM drywall sample locations.

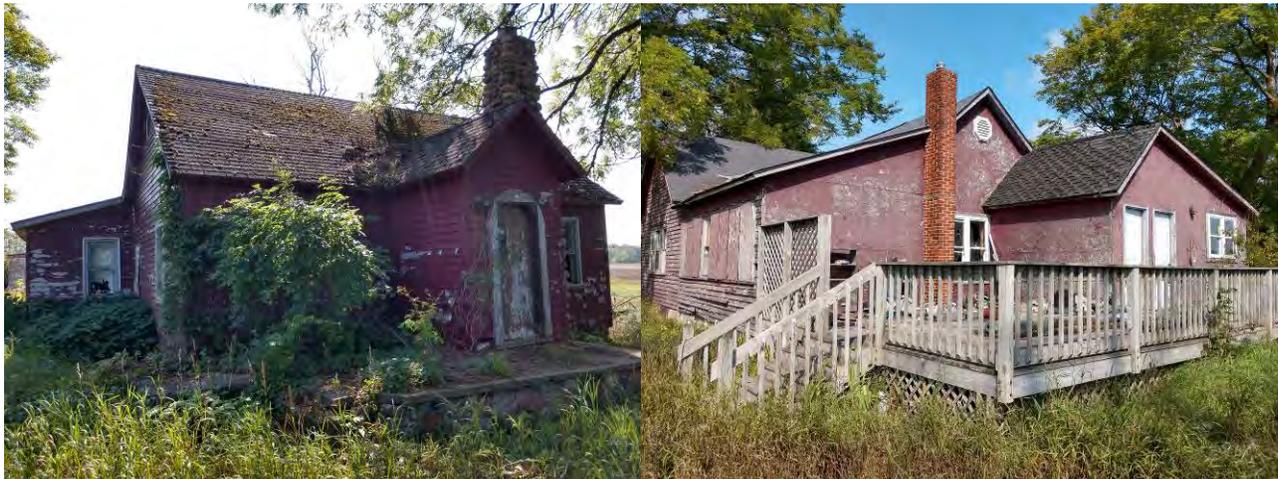
General views of residential home located at 1531 North Townline Road.

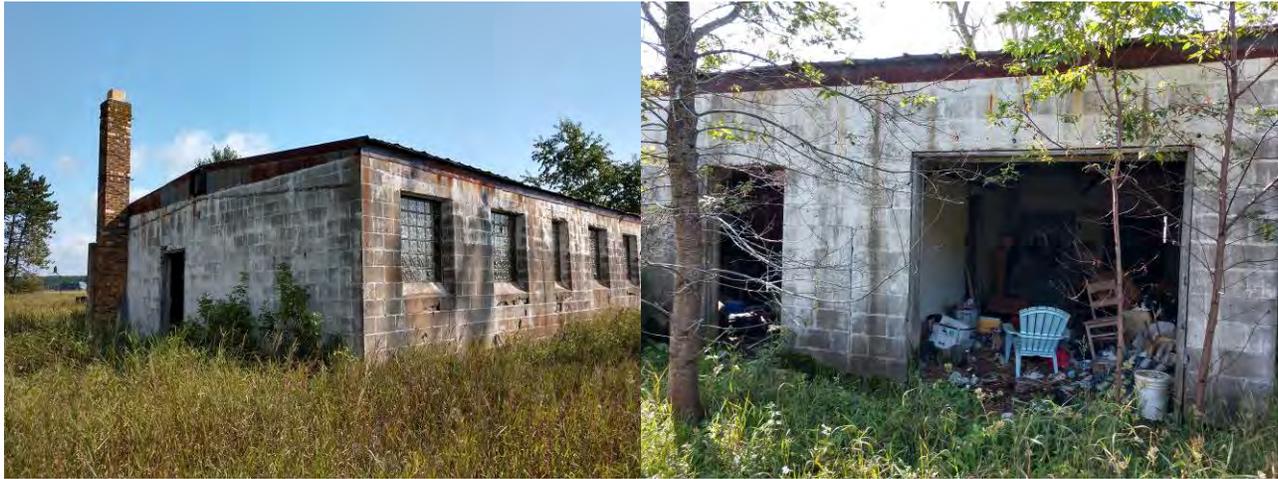
General views of outbuilding.

- No significant areas of mold were observed in the residential home located at 1531 North Townline Road. The roof of the large outbuilding has been compromised and is open to the elements.

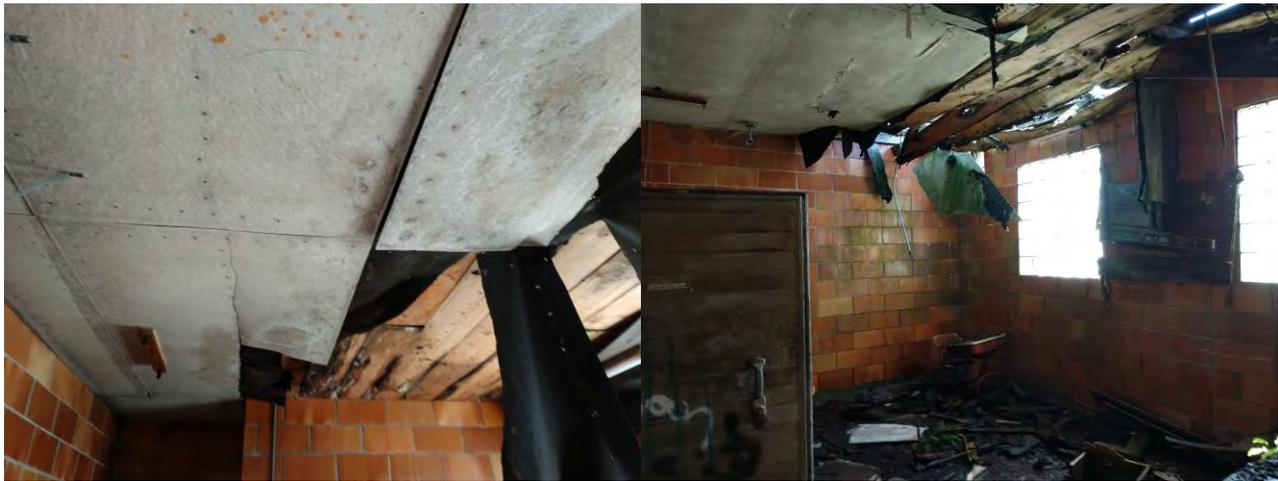
View of asbestos-containing transite panels.

The samples of the transite panels in the outbuilding and pipe wrap insulation in the basement of the residential home were determined to contain asbestos. The square/linear footage of the ACM present in the buildings is as follows:

Transite Panels – ~1,000 ft²

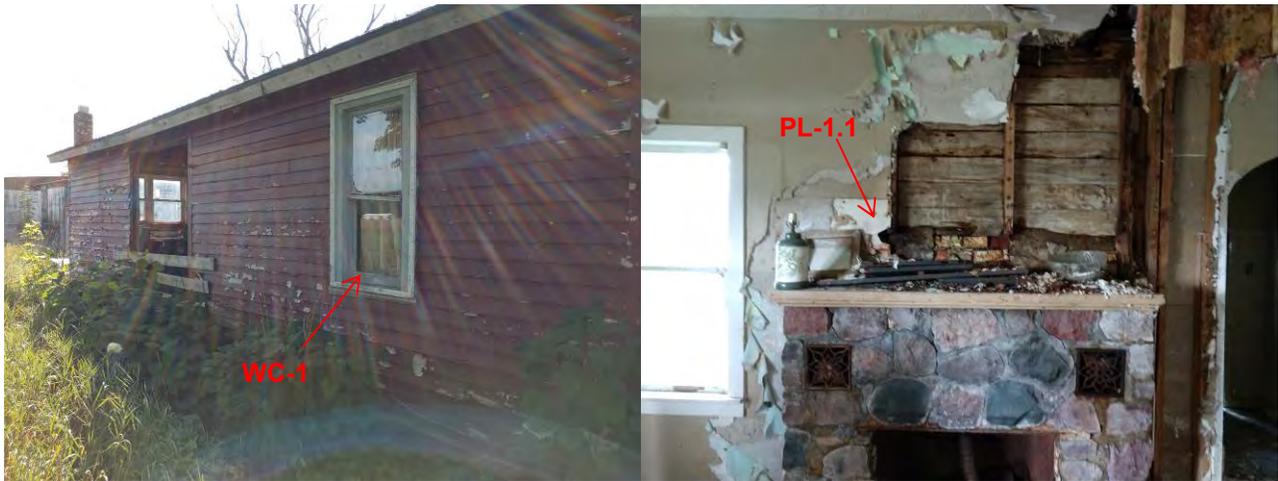
View of non-asbestos window glazing and non-asbestos plaster.

The samples of the tar paper, roof shingles, drywall, and plaster (asbestos concentration below regulatory threshold of 1%) were determined not to contain asbestos.

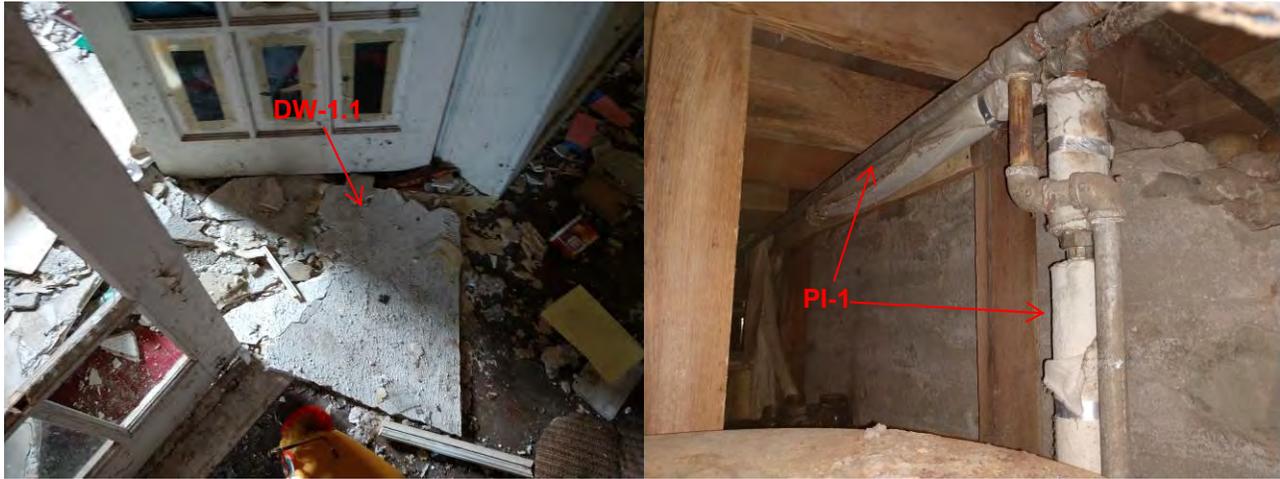
View of non-asbestos drywall and asbestos-containing pipe wrap insulation.

AirCell Pipe Wrap Insulation – ~25 linear feet*

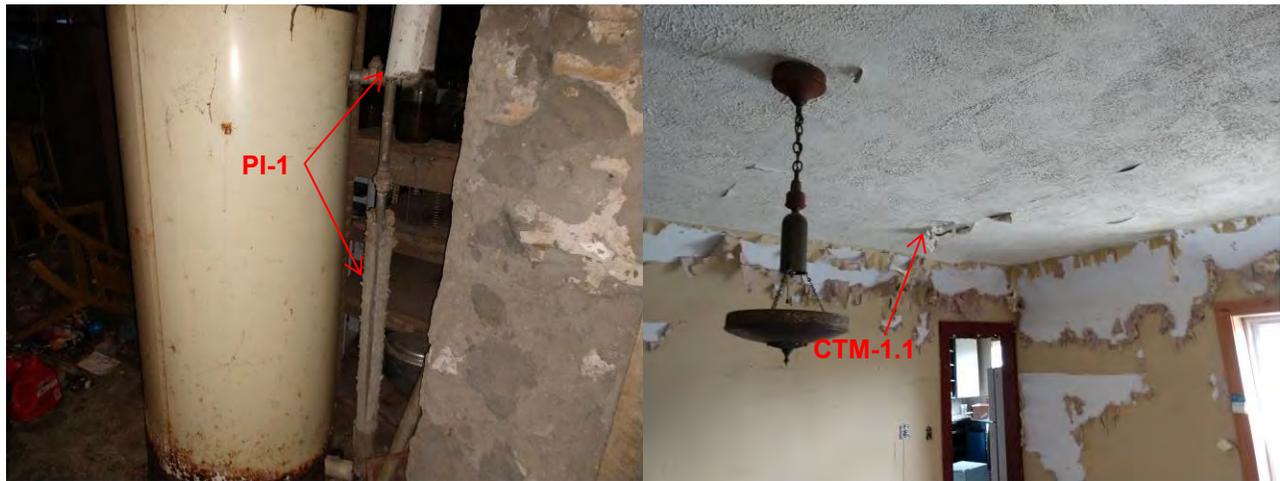
View of asbestos containing pipe wrap insulation and non-asbestos ceiling texture material.

(*AirCell pipe wrap insulation estimated due to a skunk in the basement.)

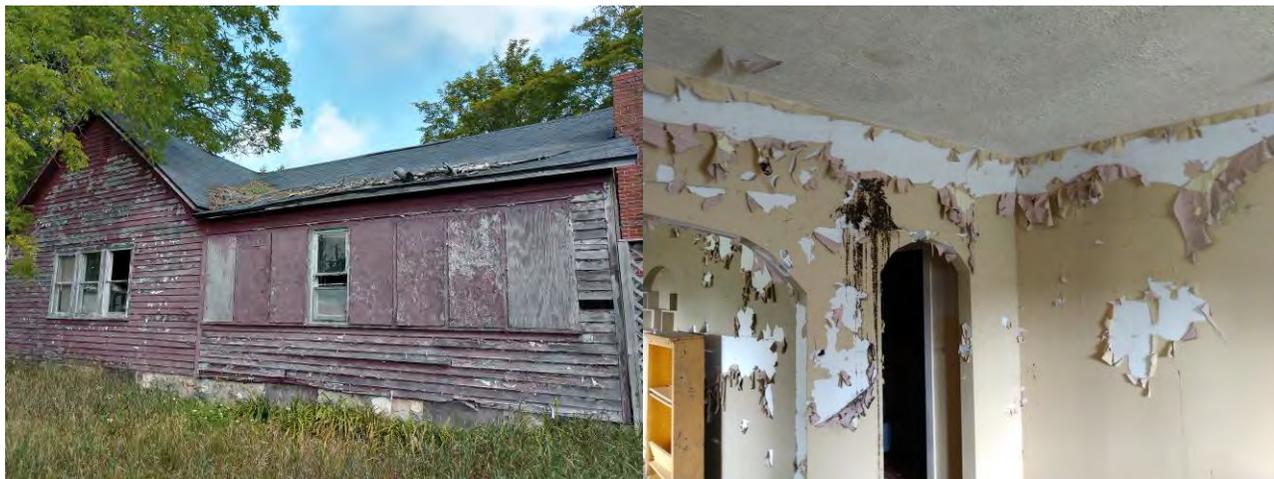
View of PS-1 & PS-2 paint composite sample locations.

The Housing & Urban Development (HUD) definition of lead-based paint is 0.5% by weight / 1.0 mg/cm² / 5,000 ppm. Paint samples PS-1 & PS-4 were found to be above the HUD limit. Paint samples PS-2 & PS-3 were determined to be below the HUD limit for lead-based paint. *A copy of the laboratory analytical report is attached.*

- The exterior burgundy paint and beige paint located on/in the residential home located at 1531 North Townline Road was found to contain lead at concentrations above the HUD limit for lead-based paint.

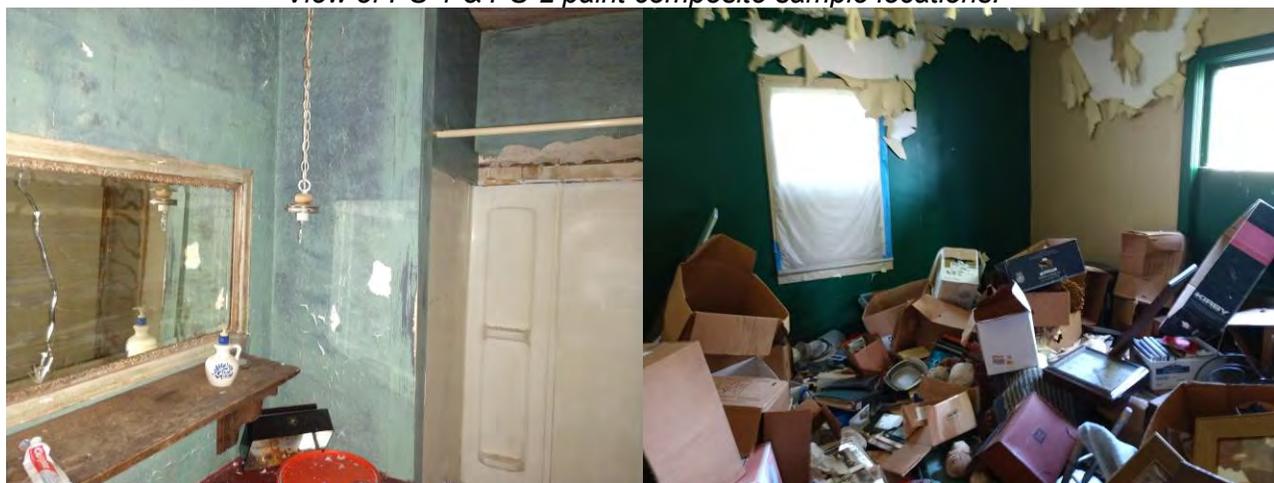
View of PS-3 & PS-4 composite paint sample locations.
